LOSS CONTROL ALERT – Scissor-lift Pinch Point

Incident

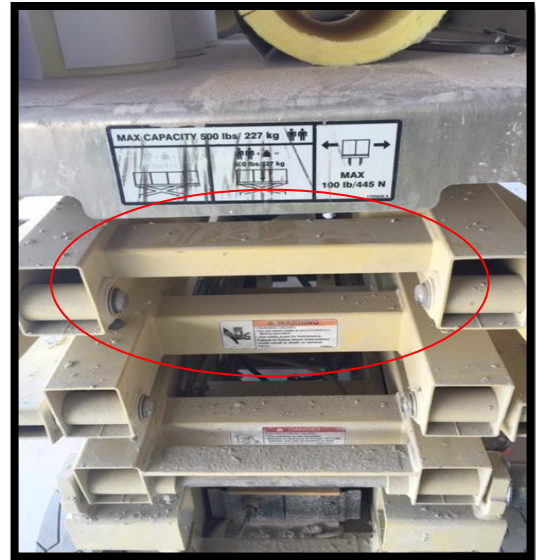
Curtain Wall/Glazier worker had his foot crushed in a pinch-point on scissor-lift frame. As two Glazier's were working on a scissor-lift together, the injured party unhooked from his anchor point and began to climb out of the lift prior to it being completely lowered. He put his foot in the crush point shown here. Suffered a metatarsal fracture.

- Foot caught in scissor-lift frame, which is not a step.
- Working in haste (end of the day, eager to go home).
- Premature exit of scissor-lift being operated by a working foreman.
- Unsafe scissor-lift use with operator not looking and communicating with partner.
- Steps, hazards and safety measures not reviewed in Daily Huddles in enough detail.

- Increase specific *Critical Safe Behavior* coaching for all lifts and machinery use, to be done daily to assist in addressing unsafe lift and machinery operation trends and coach workers to follow safe work behaviors.
- Ensure Daily Huddles are covering scissor lift safety (use Operators Manual for safe use suggestions), specifically:
 - Operator's responsibility to do a 360° look around to clear the area and communicate intended movement with partner before doing so
 - Partner is to communicate to operator if he plans to exit or enter the lift prior to doing so
 - Project stand-down by trade to specifically cover this hazard
 - Operator of lift to be in full control of lift and personnel inside the lift
 - No one to enter/exit lift until the all clear verbal command had been issued by the operator of the lift
